# Special Report 84-12

Cold Regions Research &  
Engineering Laboratory

## *Deteriorated concrete panels on buildings at Sondrestrom, Greenland*

Charles Korhonen

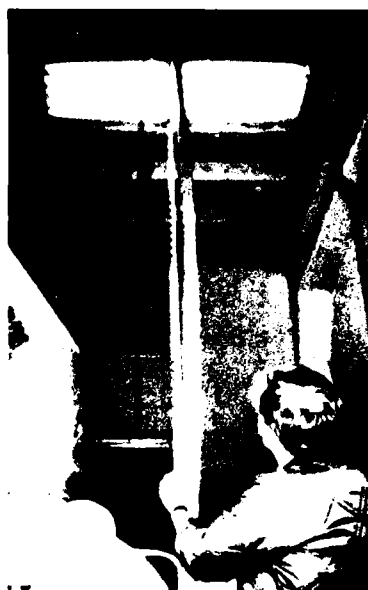
b. Bowed equipment support rod, representing a  $1/16$ -in. movement.

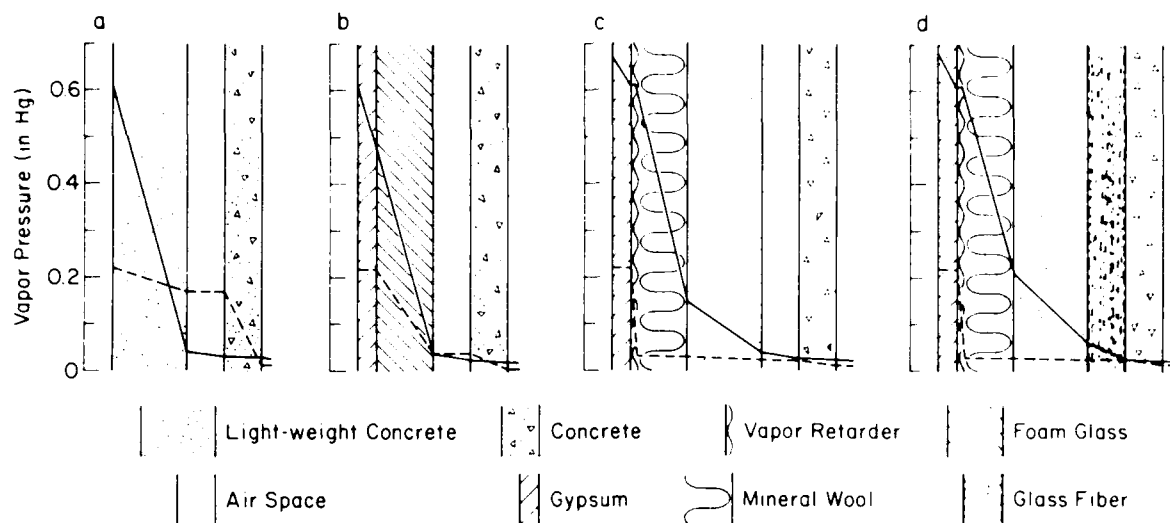
Figure 8. Vapor pressure profiles through four wall cross sections. Moisture condenses when the actual vapor pressure (dotted line) exceeds the vapor pressure of saturated air (solid line). The warm side of each wall is on the left.

-10°F and 70% relative humidity. As can be seen, condensation is more likely to occur in the two walls without a warm-side vapor retarder (Fig. 8a,b). It was in these walls that I found the most debris. Also, it was on these buildings that the wall panels seemed to be a bit more cracked. Thus, it appears that much of the deterioration of these buildings can be alleviated by adding a vapor retarder on the warm side of the walls.

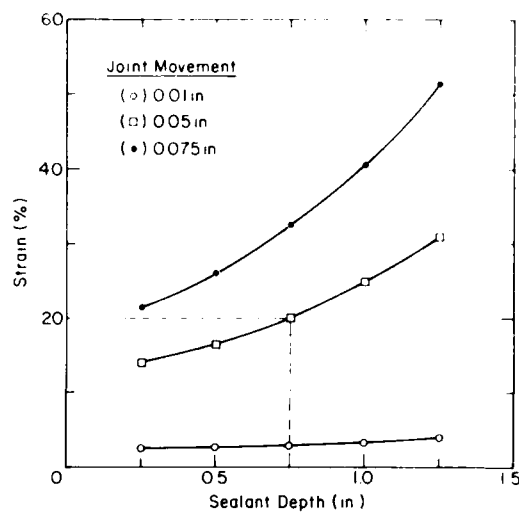
Figure 10. Relationship between movement, sealant strain and sealant depth for a 3/8-in.-wide joint. (After American Concrete Institute 1983b.)

they will return to their original shape even in very cold weather. To be effective, the sealant should not completely fill the joint. There is a definite correlation between sealant depth and joint width (Fig. 10). As an elastic material is stretched, it begins to thin, producing the greatest strain at the top and bottom surfaces. For the elastomeric sealants mentioned above, the allowable working strain is  $\pm 25\%$  (Maslow 1974). As shown in Figure 10, a 3/8-in. joint subjected to a 0.05-in. movement produces a 25% strain in a 1-in.-thick bead of sealant. However, to avoid even approaching this strain, the sealant should not be placed any deeper than 3/4 in. A polyethylene-foam backer rod should first be inserted to the proper depth in the joint, both to create the desired sealant cross section and to prevent the sealant from sticking on its bottom side.
